SERVICE BULLETIN

TRANSMITTAL SHEET <u>HC-SB-61-363</u> Propeller - Introduction of A-2051-1 Bolt with Three-Direction Safety Wire Holes

SERVICE BULLETIN HC-SB-61-363

Propeller - Introduction of A-2051-1 Bolt with Three-Direction Safety Wire Holes

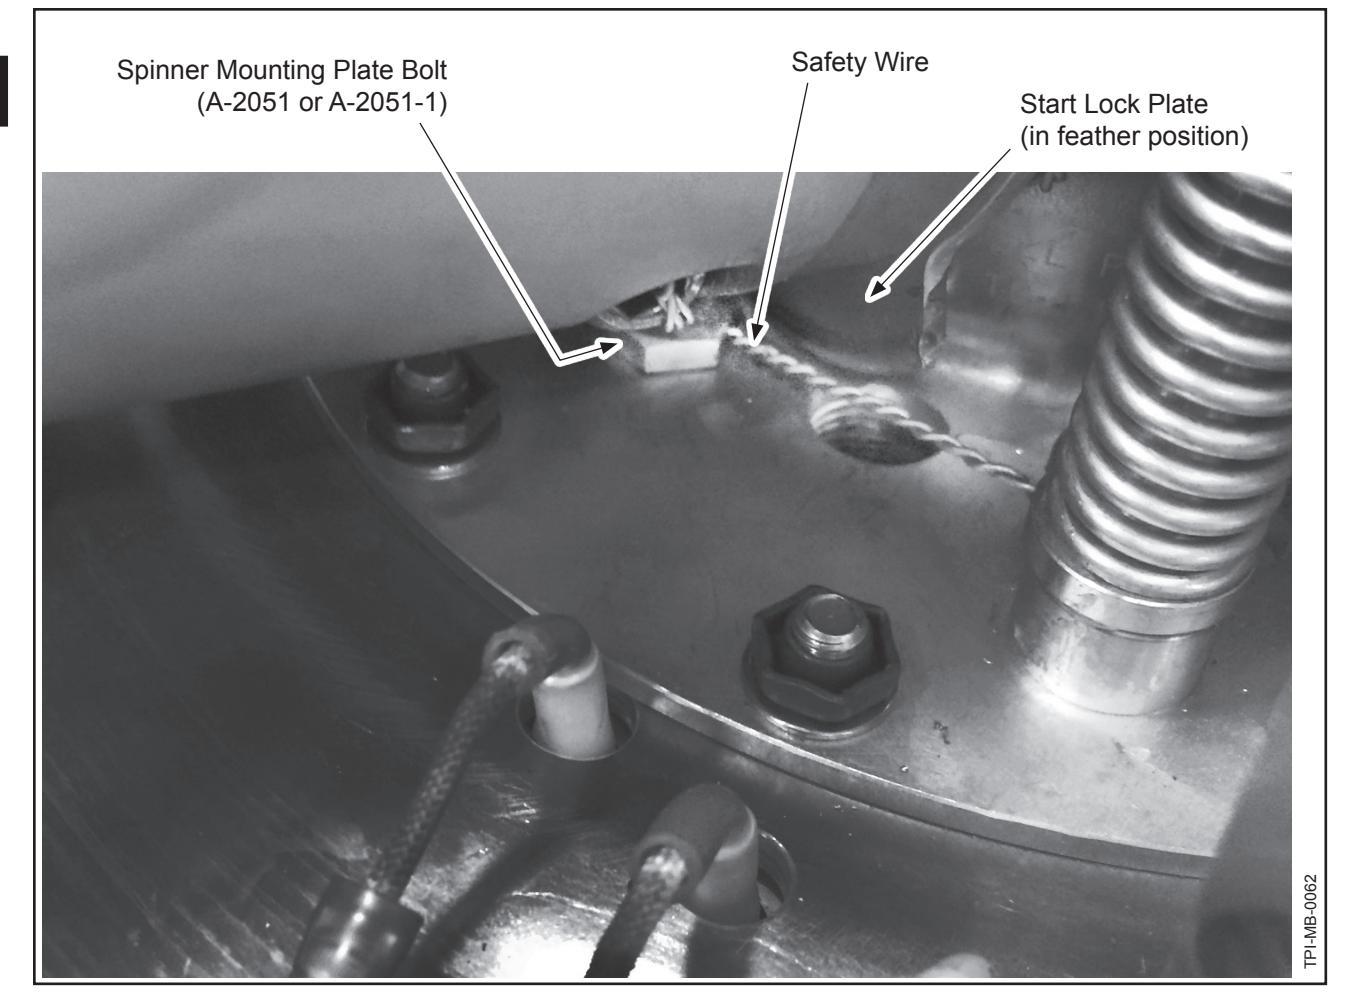
Visual Inspection Figure 1

- C. Reason
 - Hartzell Propeller Inc. has received reports of interference between the start lock plates and the safety wire securing the A-2051 bolts in the spinner mounting plate on the affected propellers.

- (a) The A-2051 bolt has only one safety wire hole through the bolt head. When the bolt is torqued, the position of the safety wire hole may cause interference between the start lock plates and the safety wire when the propeller is in feather position.

- (2) Perform the following steps at propeller overhaul or major disassembly <u>before</u> applying sealant to the clamps:
 - (a) Visually examine the start lock plates for interference with the safety wire securing the bolts in the spinner mounting plate. Refer to Figure 1.

- <u>1</u> If the start lock plates touch the safety wire:
 - <u>a</u> Reroute the safety wire for the spinner mounting plate bolts in accordance with section 3.B. in this Service Bulletin.

- <u>2</u> If the start lock plates do <u>not</u> touch the safety wire, no further action is required.
- B. Rerouting the Safety Wire for the Spinner Mounting Plate Bolts

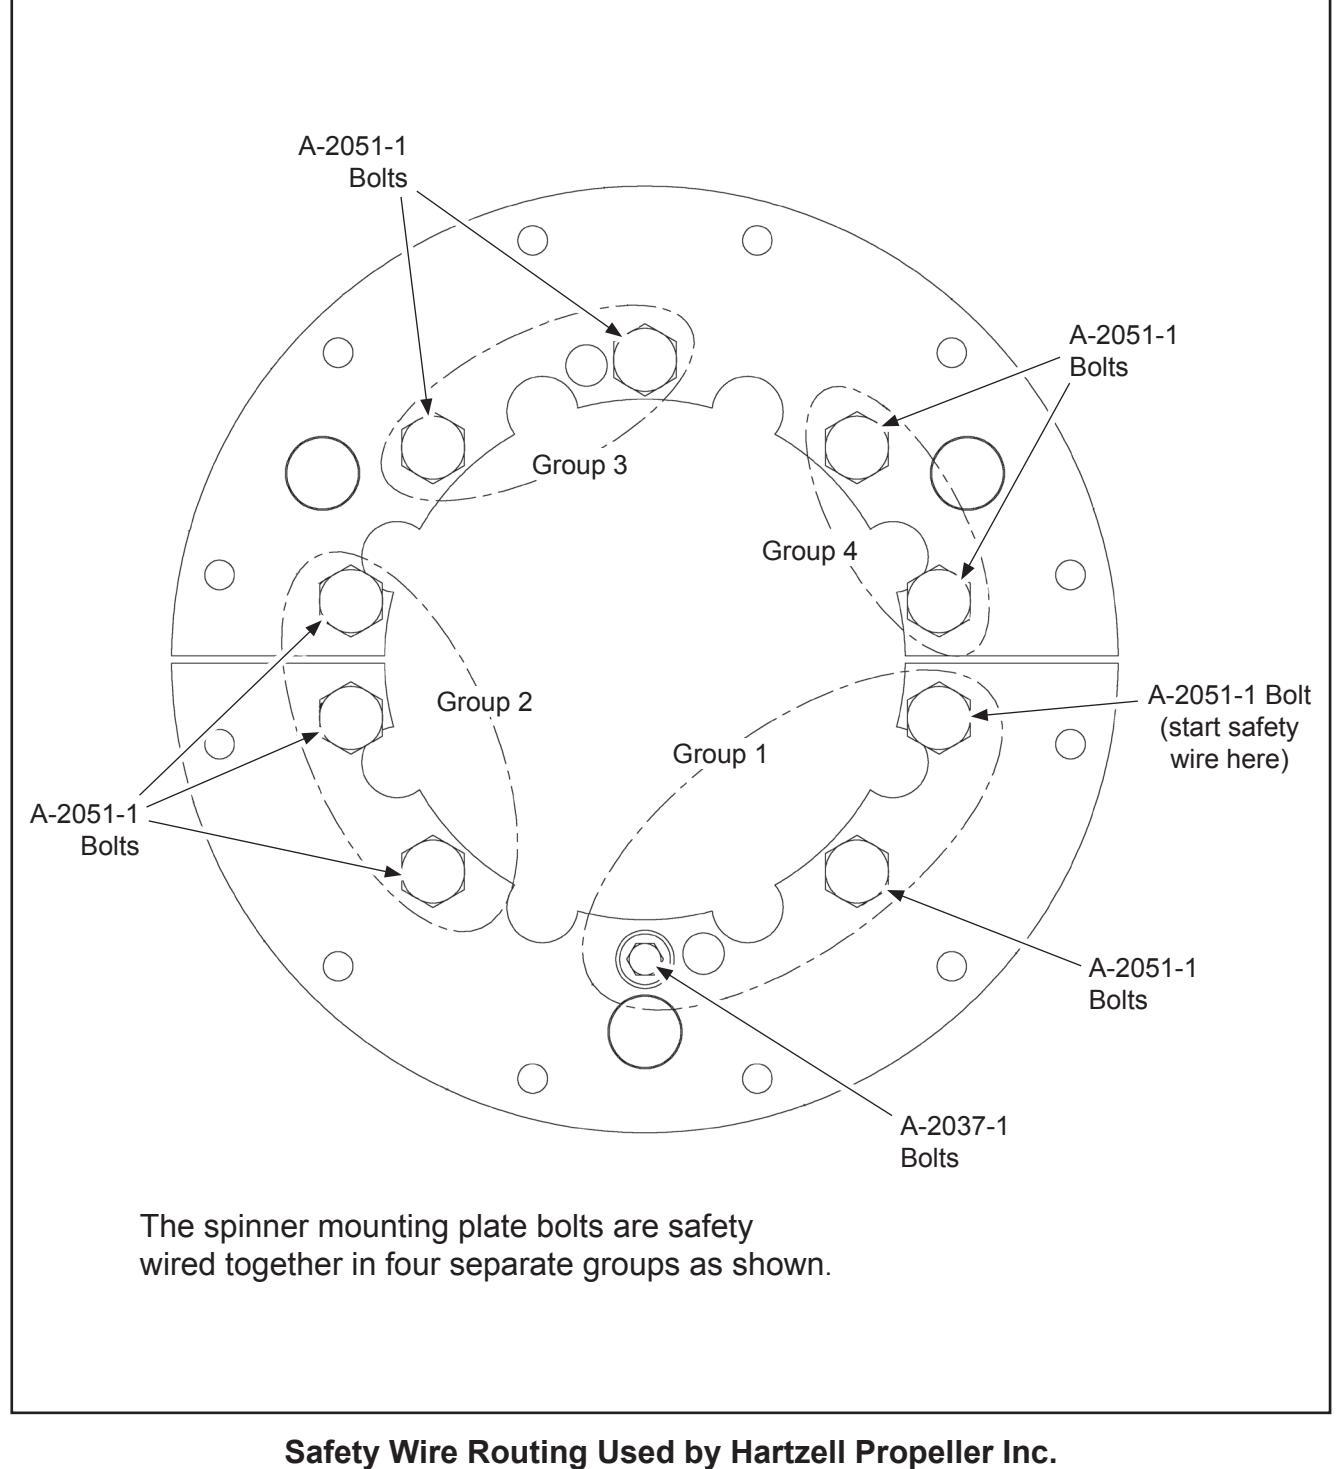
- <u>NOTE</u>: Figure 2 shows the safety wire routing used by Hartzell Propeller Inc. when nine A-2051-1 spinner mounting plate bolts are used.
 - (1) If any of the start lock plates touch the safety wire securing the bolts in the spinner mounting plate, cut the safety wire and remove the bolt at the location of the interference.

- (2) Install a new A-2051 bolt or a new A-2051-1 bolt at the location of the interference.
 - (3) Torque the new A-2051 bolt or new A-2051-1 bolt 13.5 16.5 Ft-Lb (18 22 N•m).

- (4) Examine the position of the safety wire hole(s) in the new A-2051 bolt or new A-2051-1 bolt.
 - (a) If safety wire can be installed without interfering with the start lock plate:

- <u>1</u> Safety wire the bolts together with 0.032 inch (0.82 mm) diameter stainless steel wire CM131 in accordance with NASM33540.
 - Complete the propeller overhaul in accordance with Hartzell Propeller Inc. Steel Hub Turbine Propeller Maintenance Manual 118F (61-10-18).

- (b) If the safety wire interferes with the start lock plate, repeat steps 3.B.(1) thru 3.B.(4) as necessary.
