1. Planning Information

- A. Effectivity
 - (1) Hartzell Propeller Inc. 5D31-NK366B1() Raptor turbine propellers with serial numbers listed in Table 1 are affected by this Alert Service Bulletin.

C. Reason

Document No. HC-ASB-61-405 Date of Issue: Oct 13/23

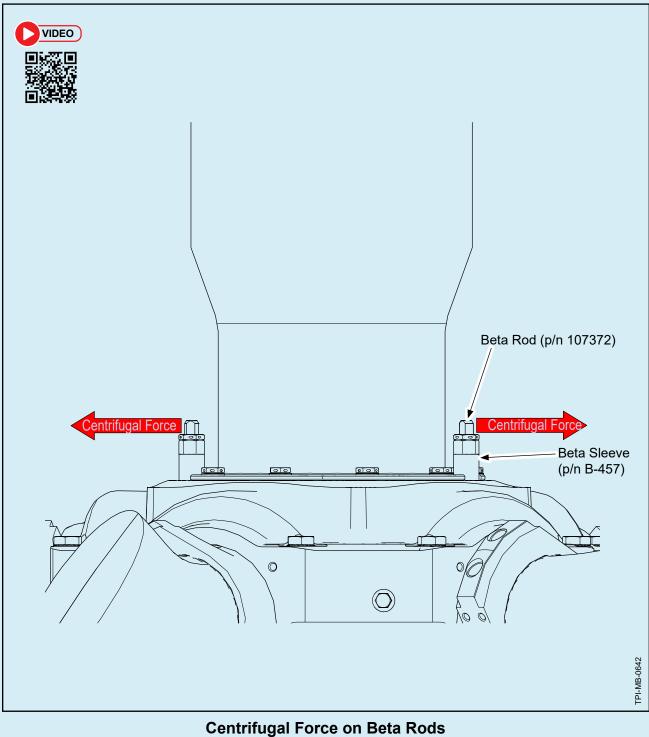
109438 Beta Rod Support Ring and 109235 Beta Compression Spring Figure 2

- (1) During operation, centrifugal force on the 107372 beta rods can create friction that affects the response of the electronic beta system used on the affected propellers.
 - (a) Centrifugal force causes the top (cylinder-end) of the 107372 beta rods to move outward, creating friction against the B-457 beta sleeves as the beta rods move. Refer to Figure 1.
- (2) Hartzell Propeller Inc. is introducing a design change to reduce friction and increase the return spring force of the electronic beta system used on the affected propellers. Refer to Figure 2.
 - (a) The new design incorporates a beta rod support ring (p/n 109438) to prevent outward movement of the beta rods at the cylinder-end, stronger compression springs (p/n 109235) for increased return force, and a redesigned spring guide sleeve (p/n A-466-1, Rev. I) with a smaller OD to reduce friction.

- (3) This Alert Service Bulletin introduces the 109235 beta compression spring as a replacement for the B-458 beta compression spring on the affected propellers.

- (8) Hartzell Propeller Inc. will provide the parts listed in the Material Information section and warrant the labor costs associated with the installation of the 109438 beta rod support ring and 109235 beta compression spring.
