HARTZELL PROPELLER INC.
SERVICE BULLETIN
HC-SB-30-390

Propeller - Spinner/Anti-ice Travel Tube Interference

- (1) Hartzell Propeller Inc. has been informed that there is a possible interference between the anti-ice travel tube and the spinner dome that can result in damage to the spinner dome.

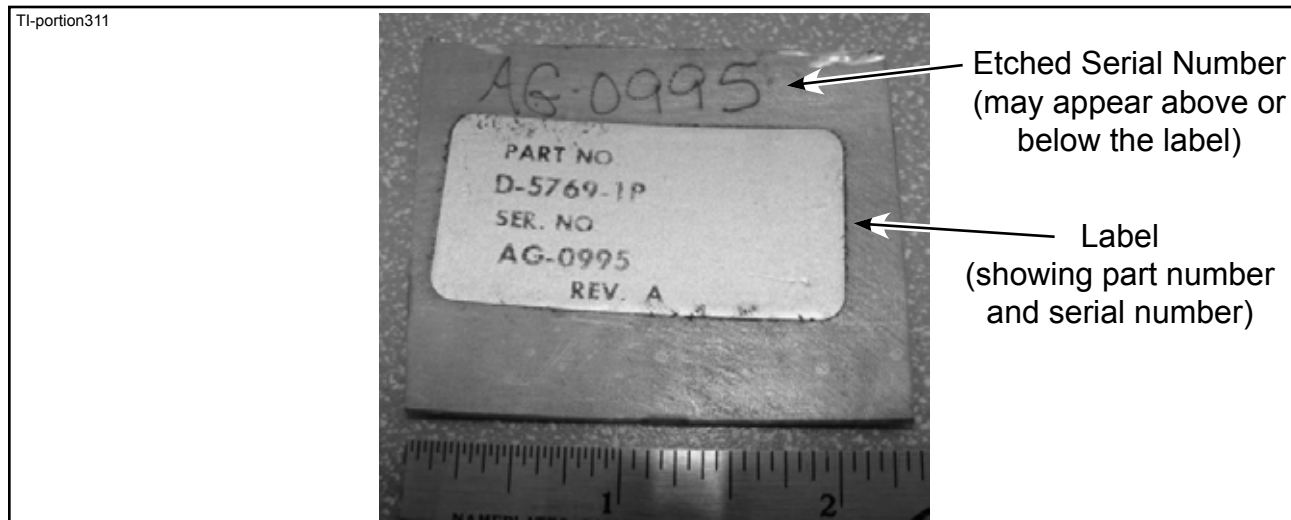
Example Portion of the Retired Spinner Dome
Figure 1

- (1) Hartzell will supply the replacement 108445 travel tube assembly, and a 107591(P) spinner dome (if damaged/repaired) on propellers affected by this Service Bulletin.
 - (a) If the spinner dome requires replacement, the dome must have a portion of the cut out to include the part number and serial number. Refer to Figure 1. This portion must be returned to Hartzell Product Support.
 - (b) Hartzell Propeller will cover standard shipping for affected spinner pieces. Contact Hartzell Product Support for shipping account information.
 - (c) Return Material Authorization is not required.
 - (d) DO NOT SEND THE WHOLE DOME.
- (2) Complete the compliance/claim form (located on page 4 of this Appendix) to order the components required.
- (3) The components will be sent and the order will reference the Warranty approval number.
